# Tree Inventory and Assessment

Angeline Street North  
Colborne Street West to Kent Street

Prepared For:  
City of Kawartha Lakes

April 2019

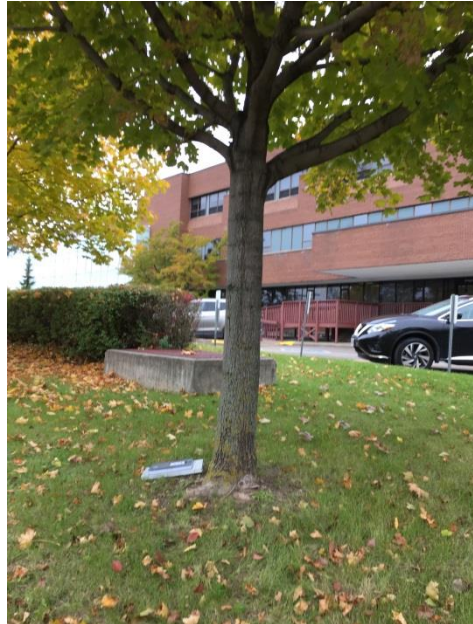
Photograph 1. Typical healthy Norway Maple – November 26, 2018.

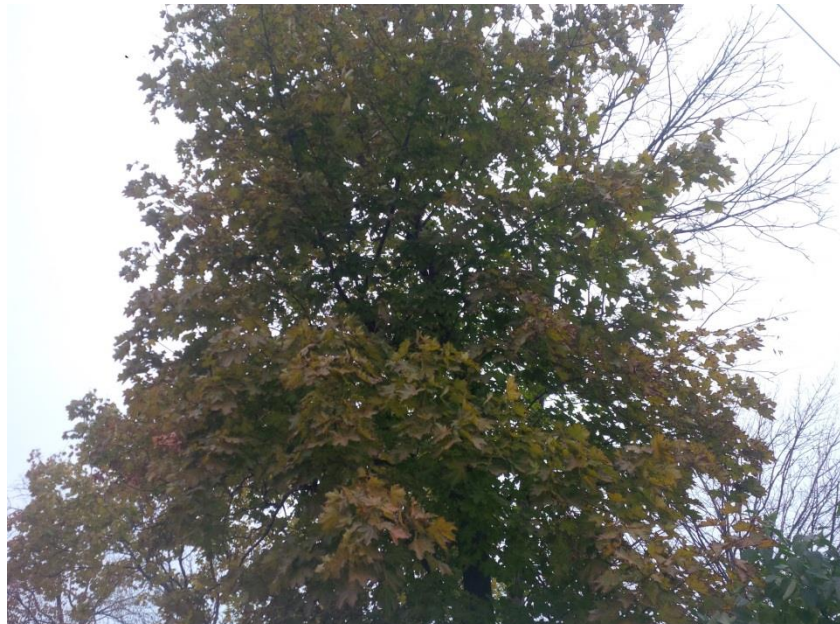
Photograph 2. Typical Norway Maple in fair health – November 26, 2018.

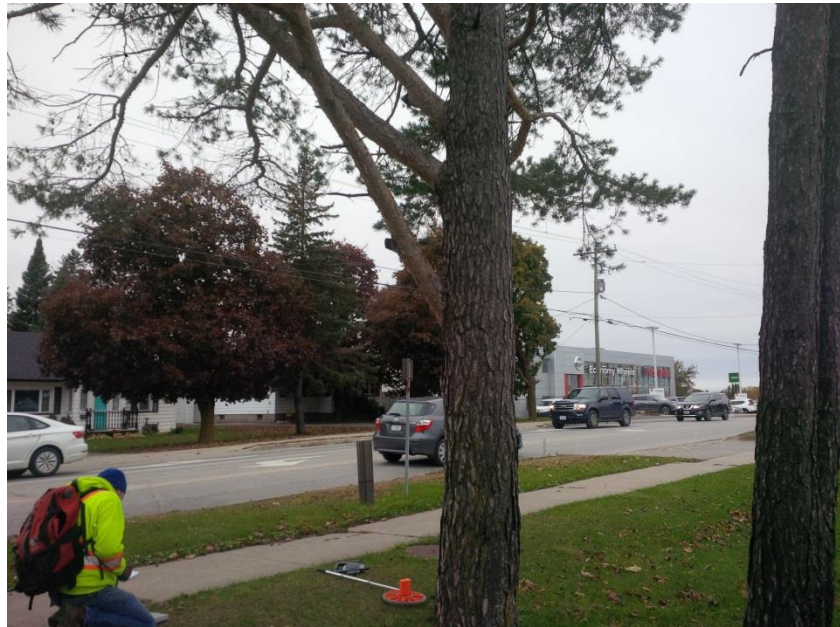
Photograph 3. Typical healthy Scots Pine – November 26, 2018.

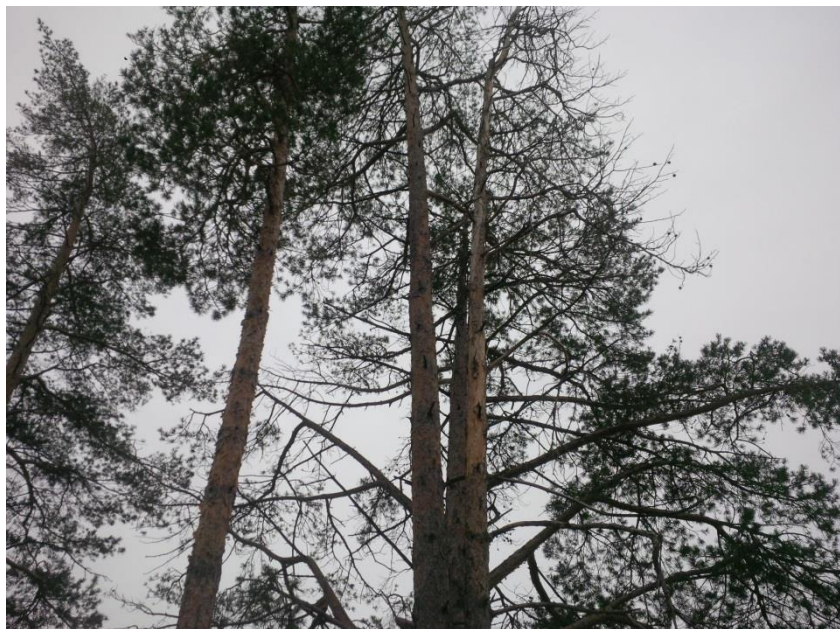
Photograph 4. Typical Scots Pine in fair health – November 26, 2018.

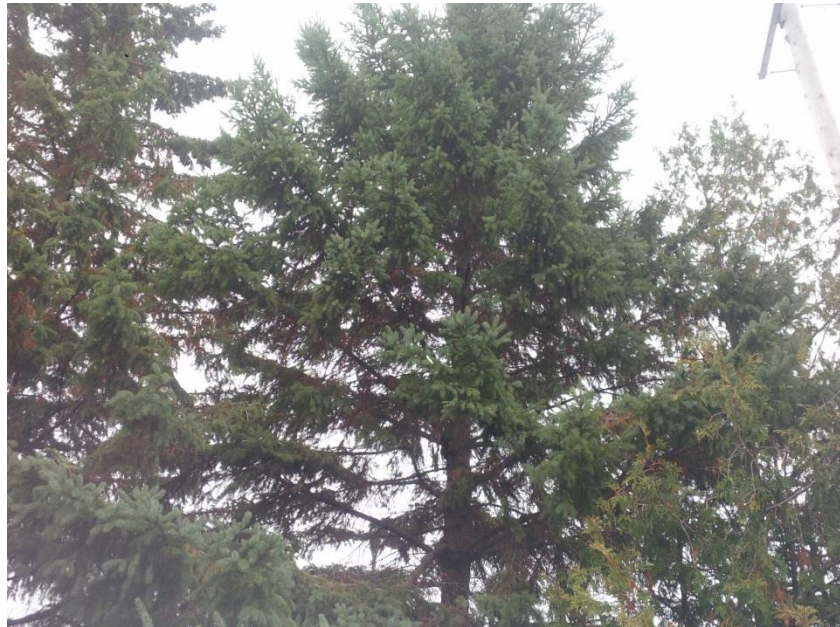
Photograph 5. Typical healthy White Spruce – November 26, 2018.

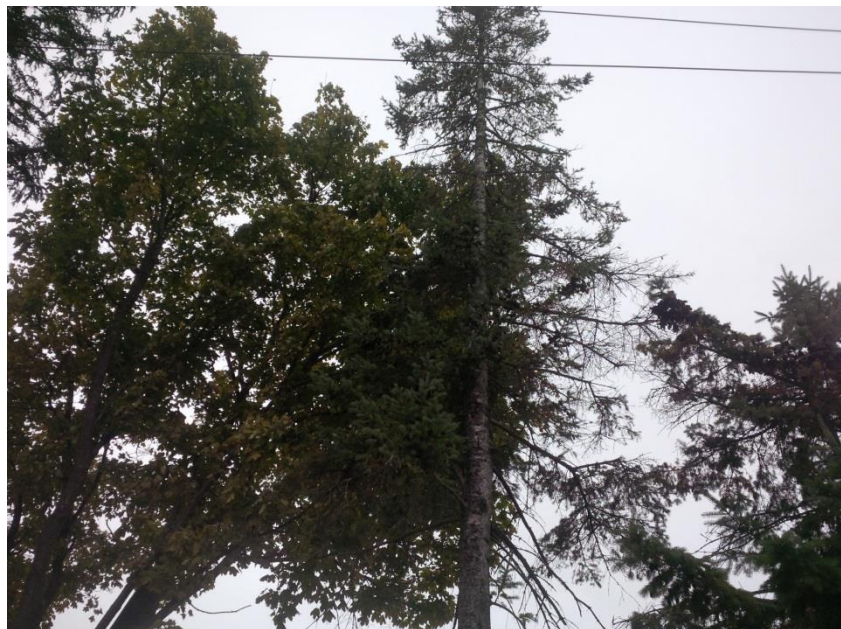
Photograph 6. Typical White Spruce in fair health – November 26, 2018.

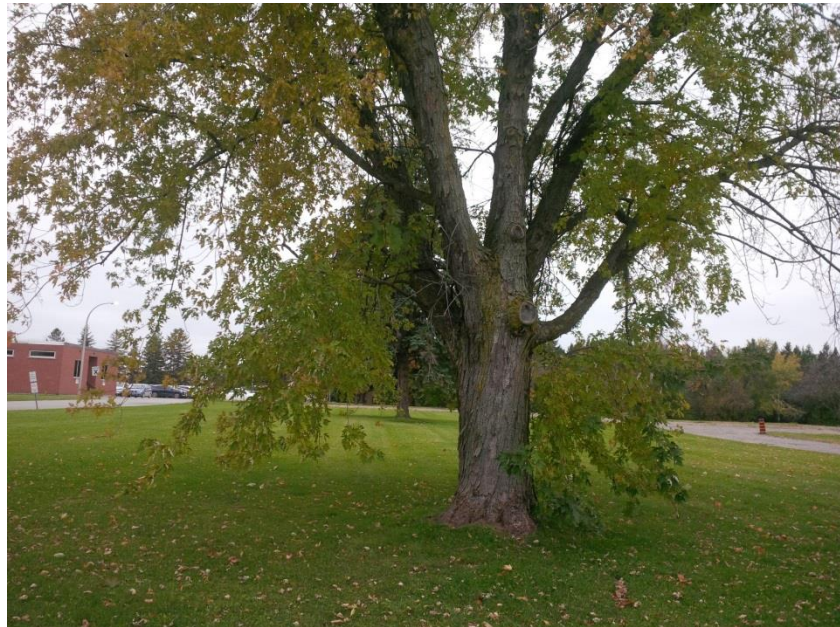
Photograph 7. Silver Maple in good health – November 26, 2018.

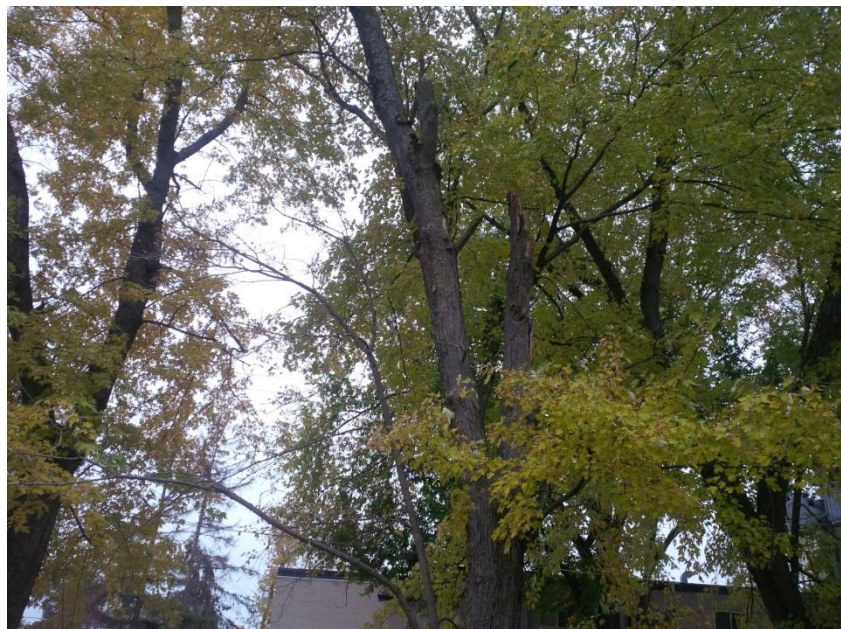
Photograph 8. Silver Maple in poor to fair health – November 26, 2018.

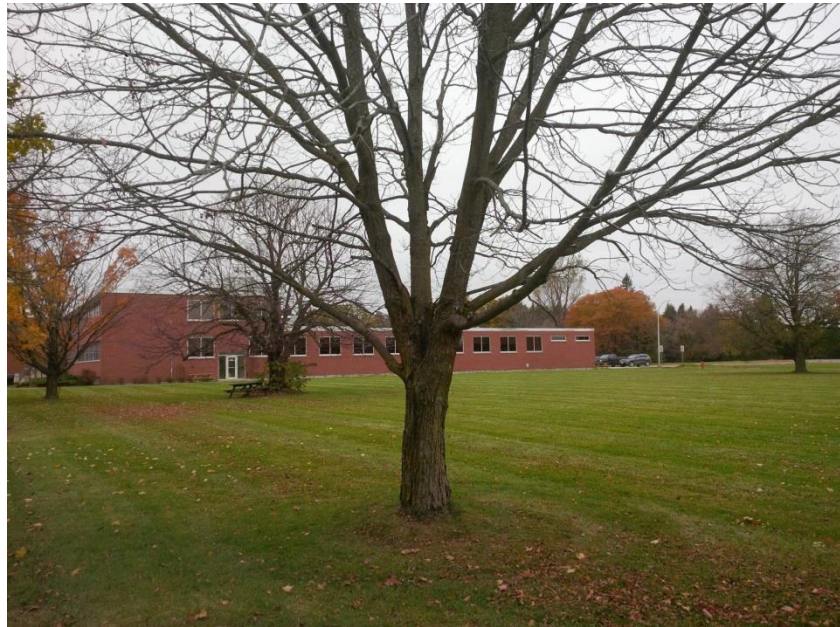
Photograph 9. Red Maple exhibiting no hazard – November 26, 2018.

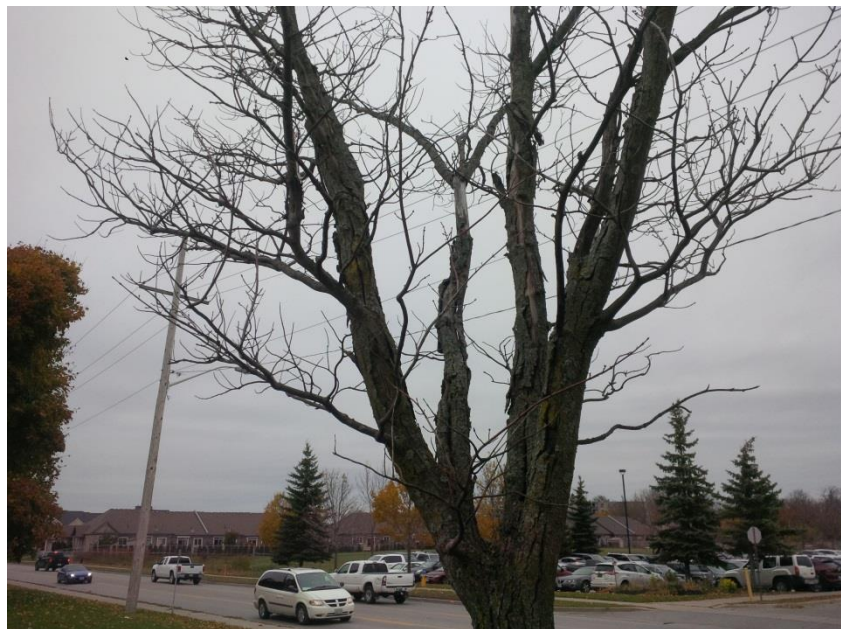
Photograph 10. Red Maple exhibiting moderate/high hazard potential – November 26, 2018.

In addition, consideration by the City of Kawartha Lakes, in consultation with the landowner, to remove some existing trees that exhibit a moderate/high to high hazard may also be warranted.

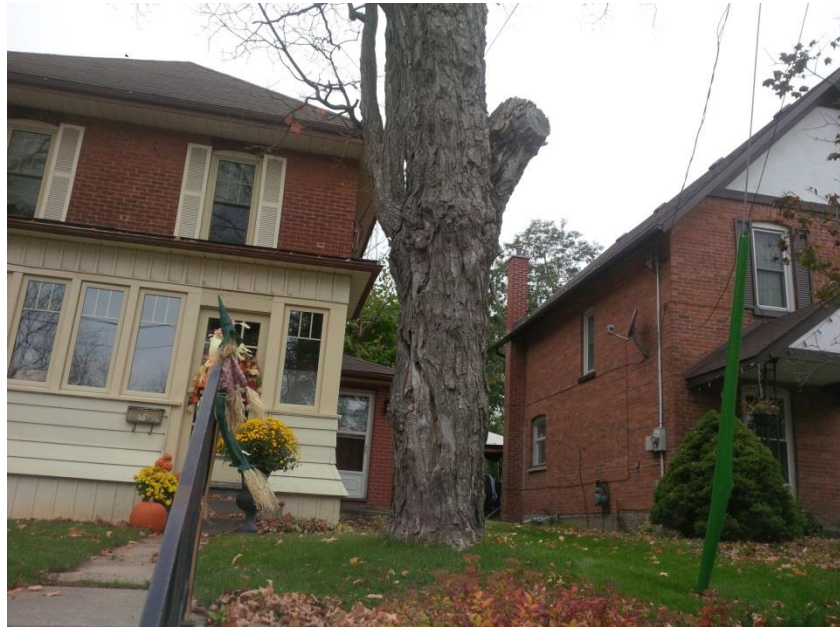
Photograph 11. Sugar Maple exhibiting moderate hazard potential – November 26, 2018.

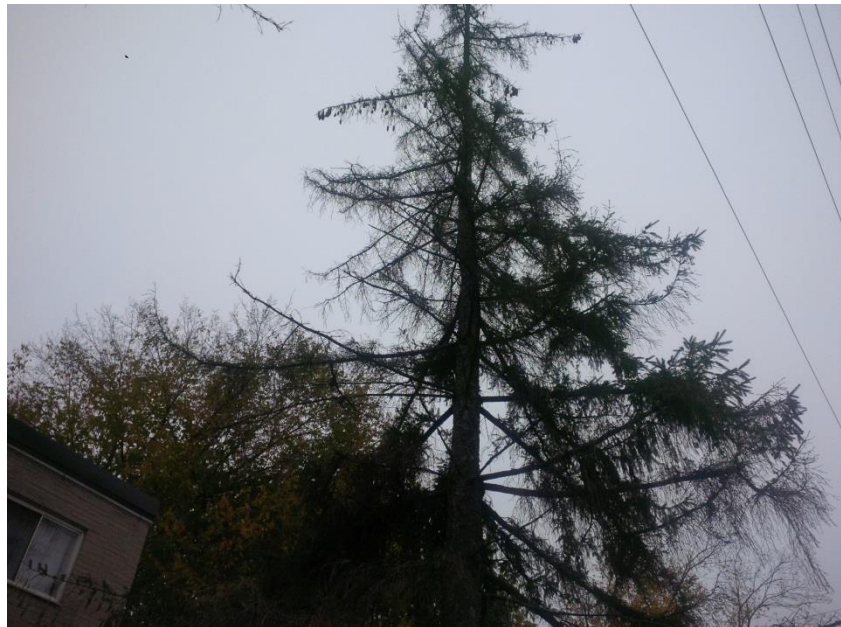
Photograph 12. Norway Spruce exhibiting moderate/high hazard potential – November 26, 2018.

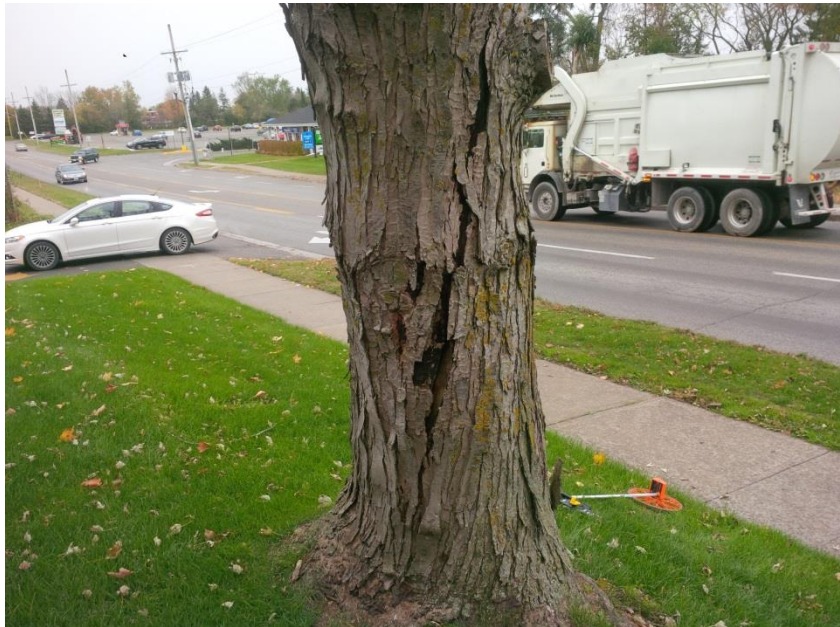
Photograph 13. Silver Maple exhibiting moderate/high hazard potential – November 26, 2018.

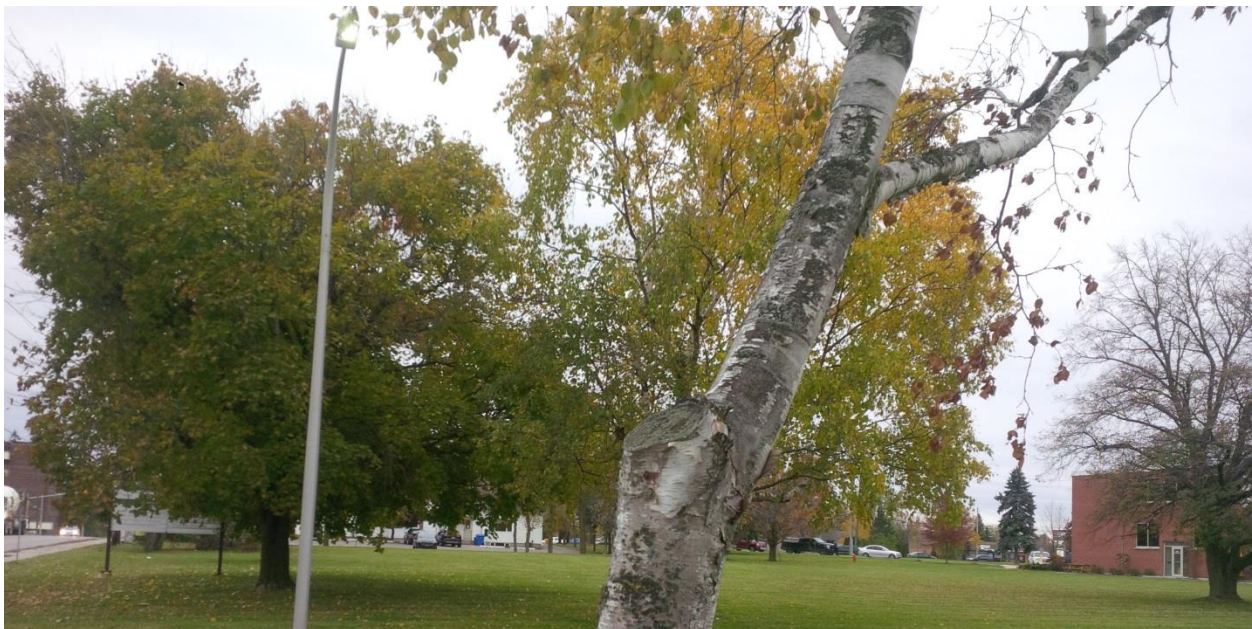
| Tree ID | Common Name | Latin Name | DBH (m) | Station | Offset | West | Offset to<br>Dripline | Condition | | Field Comments |
|---|---|---|---|---|---|---|---|---|---|---|
| A025 | White Birch | Betula papyrifera | 0.27 | 18+340 | | 10.5 | | Fair/Poor | Moderate | Callused Wounds |

Photograph 14. White Birch exhibiting moderate hazard potential – November 26, 2018.
