**VOLUME 2: HERITAGE IMPACT ASSESSMENT**

**BLACK RIVER ROAD/VICTORIA FALLS BRIDGE (STRUCTURE ID 400019)  
BLACK RIVER ROAD OVER THE BLACK RIVER**

**CITY OF KAWARTHA LAKES, ONTARIO**

**DRAFT REPORT**

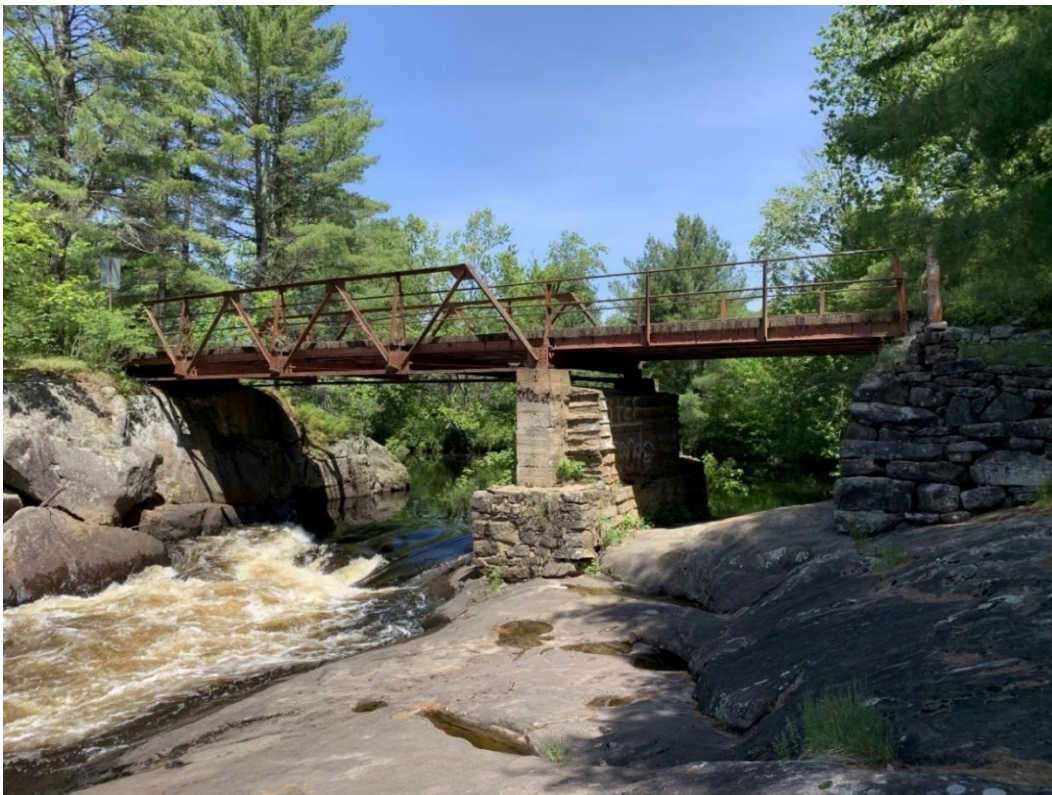
Figure 3: South elevation of the subject bridge showing the half-through Warren truss main span on the left and deck girder approach span on the right (ASI 2020)

The superstructure of Black River Road Bridge is a half-through (or pony) Warren truss structure with a deck girder approach span. The western, or main, span consists of a half-through Warren truss with riveted steel beams. The river channel flows beneath the main span. The eastern, or approach, span consists of a deck girder structure and connects the main span to the eastern bank, crossing rock and sloped land. Rolled steel I-beam stringers that extend the length of both spans, stamped with 'Jones & Laughlin', supporting a timber deck. Steel floor beams support the western truss span only. A timber deck surface extends the length of the bridge. The timber deck surface is protected further by longitudinal steel plates anchored to the wood deck at the wheel track locations. The gravel wearing surface of the road extends onto the bridge and an accumulation of gravel and dirt has resulted in grasses and vegetation growing along the curbs. A double steel pipe railing system spans the entire length of the bridge, providing the only barrier on the north and south sides on the eastern deck girder span. The substructure consists of stone abutments and a single concrete and stone pier. Stone abutments support the bridge at the east and west sides; natural rock is utilized on the west side and a dry fit stacked stone wall atop the natural rock outcrop forms the abutment on the east side. The single pier is constructed of stone and concrete and consists of a random-coursed stone footing with concrete mortar, two square cast-in-place concrete support columns, and a later stone and concrete addition to the centre, likely for additional reinforcement. The stone footing was likely originally parged with concrete, as remnants of this parging are evident on the top and the west side. Two square columns support the eastern most floor beam of the western truss span. The south column has '1937' stamped into the top, visible when looking down towards the pier from the bridge deck. The stone and concrete addition shows visible striations where the rough timber formwork was used during construction.
